Inspection Report

Complete Building Inspection Services

6 Yarle Crescent, Flinders, NSW, 2529

Pest And Building Inspection

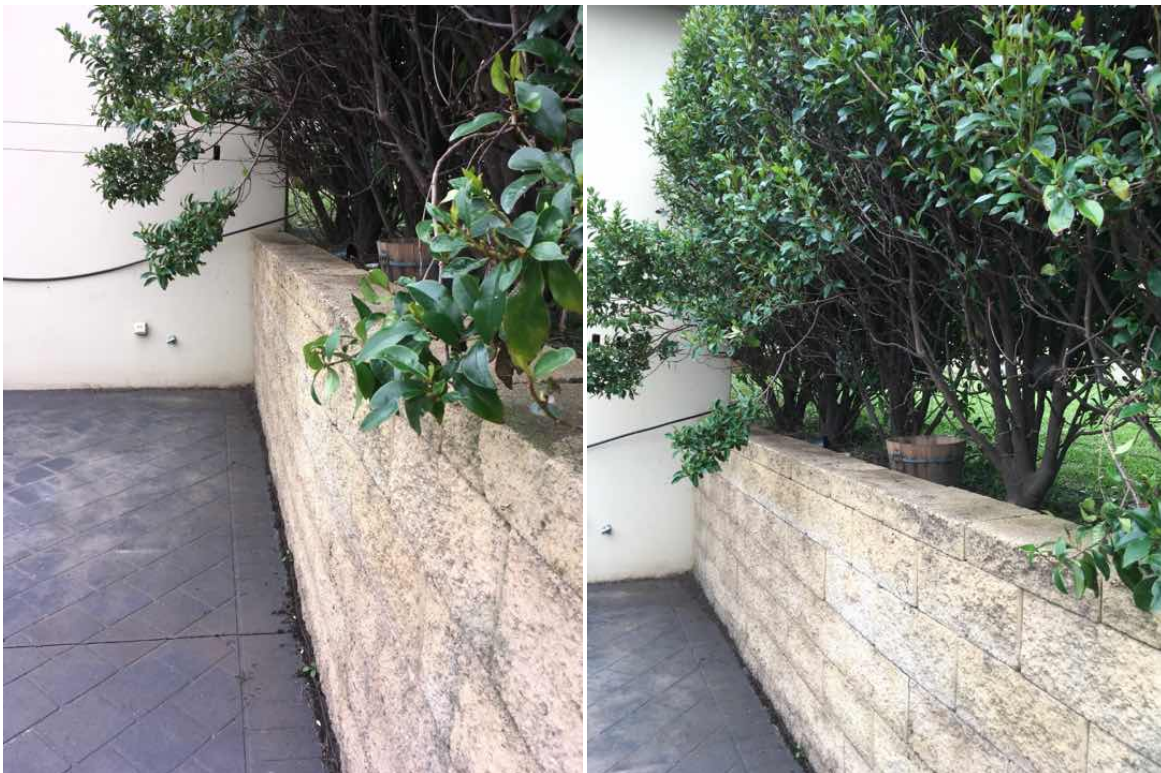
Settlement and movement apparent to the rear keystone retaining walls noted. Retaining walls appear in a functional condition at the time of inspection although future repairs and improvements maybe required if further settlement and movement occurs. Monitor same regularly and seek further advice if required. removal of adjacent trees is recommended

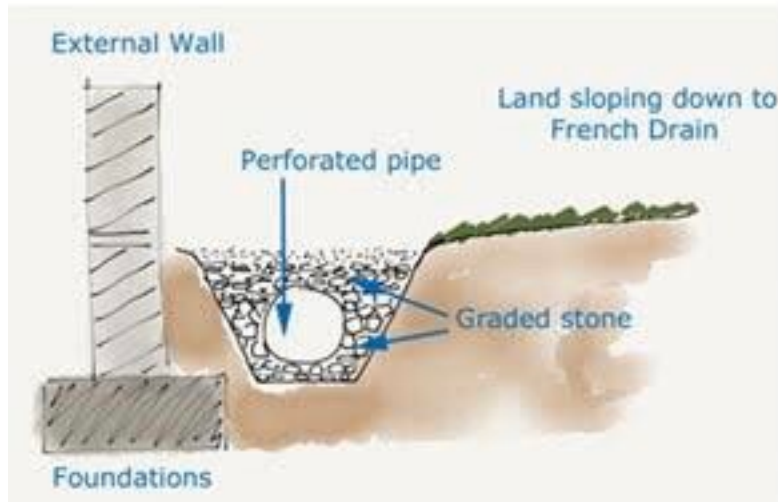
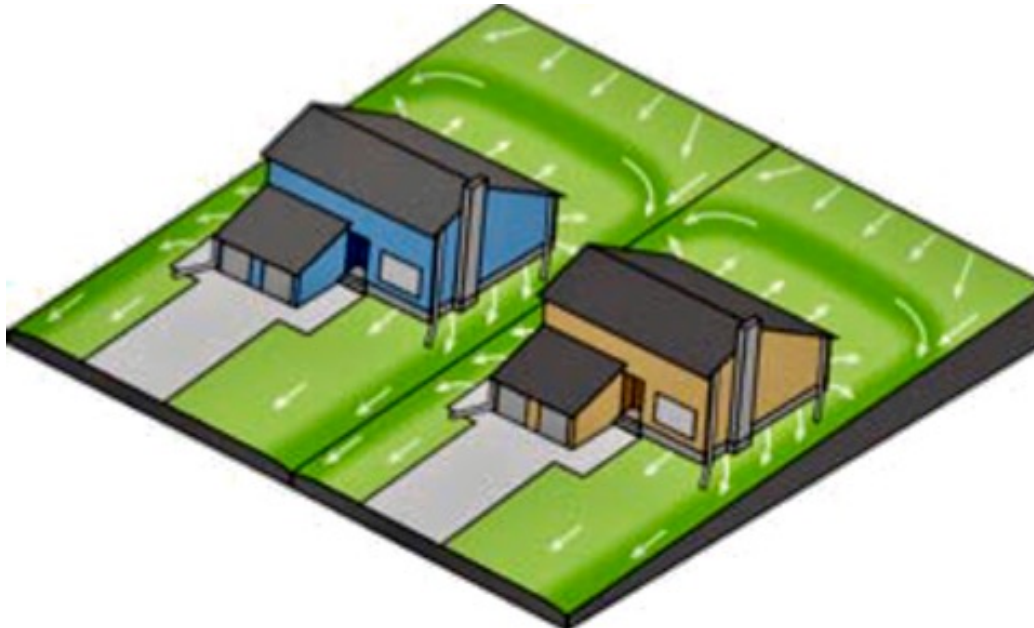
The ground levels along the perimeter walls at the rear of the home did not appear to fall away from the property walls sufficiently due to the natural landscape and contour. Recommendations: This will need to be assessed during a period of rainfall and if surface water appears to be entering the sub floor if applicable or ponding against the perimeter walls, engage a plumber or landscaper to assess and rectify as required. All drains should be regularly checked by a plumber and kept clean of debris to allow surface water to be carried away from the dwelling.

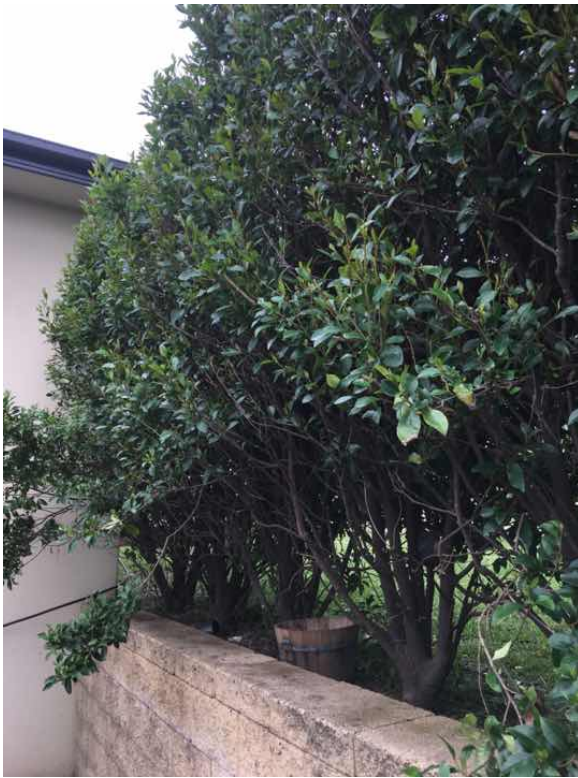
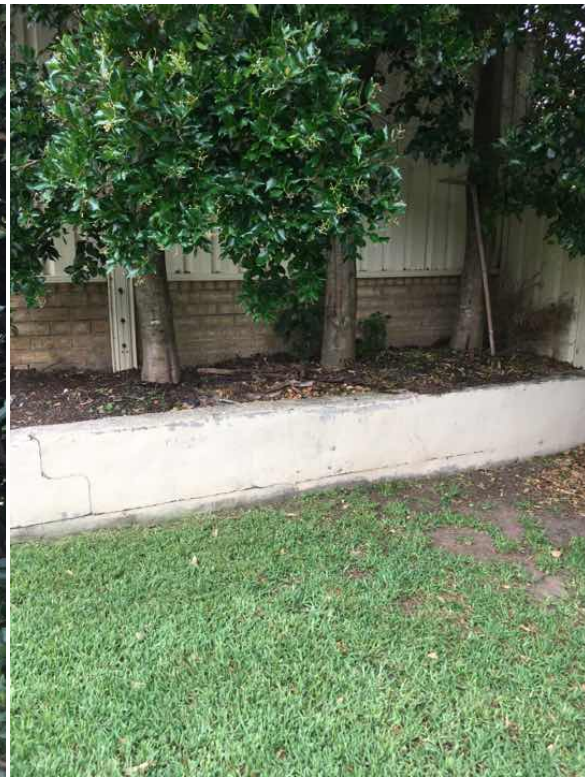
Trees/palms are close to the retaining walls. These appear to have caused some wall movement.

Recommendations: Trees close to the dwelling or retaining wall have the potential to cause significant cracking in the future. Removal of trees in accordance with an arborists advice and council approval is recommended.

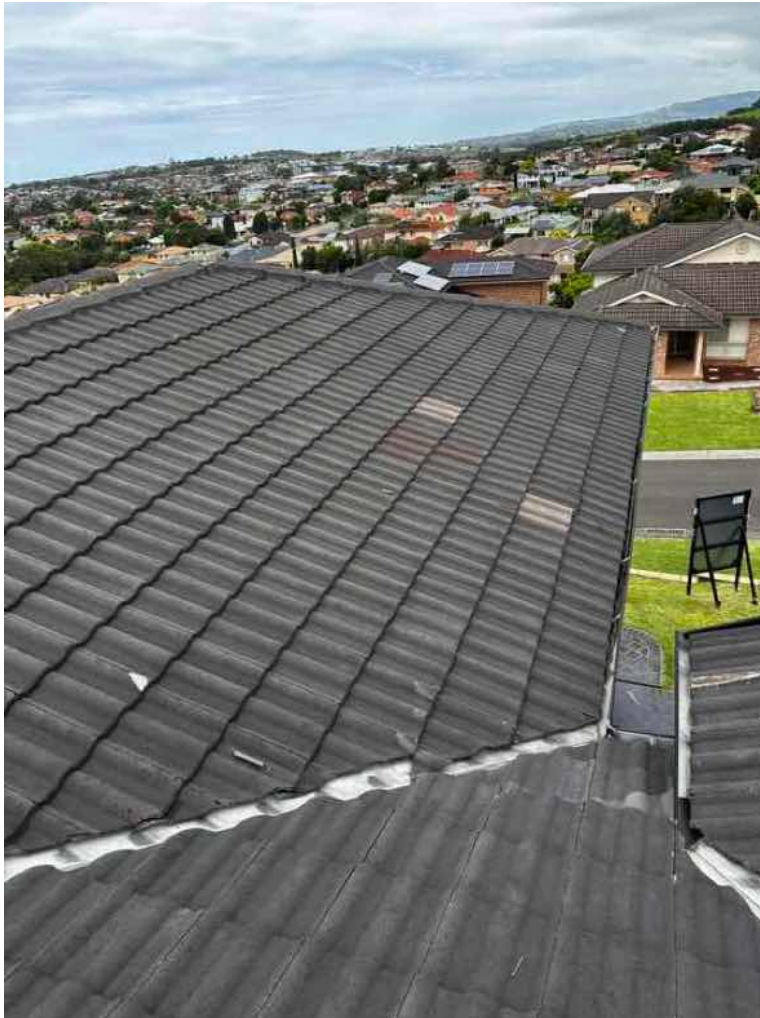
Chipped/cracked corners to individual tiles noted. This is a common occurrence with age and often does not result in roof leaks however we recommend replacement of affected tiles as a precautionary maintenance item.

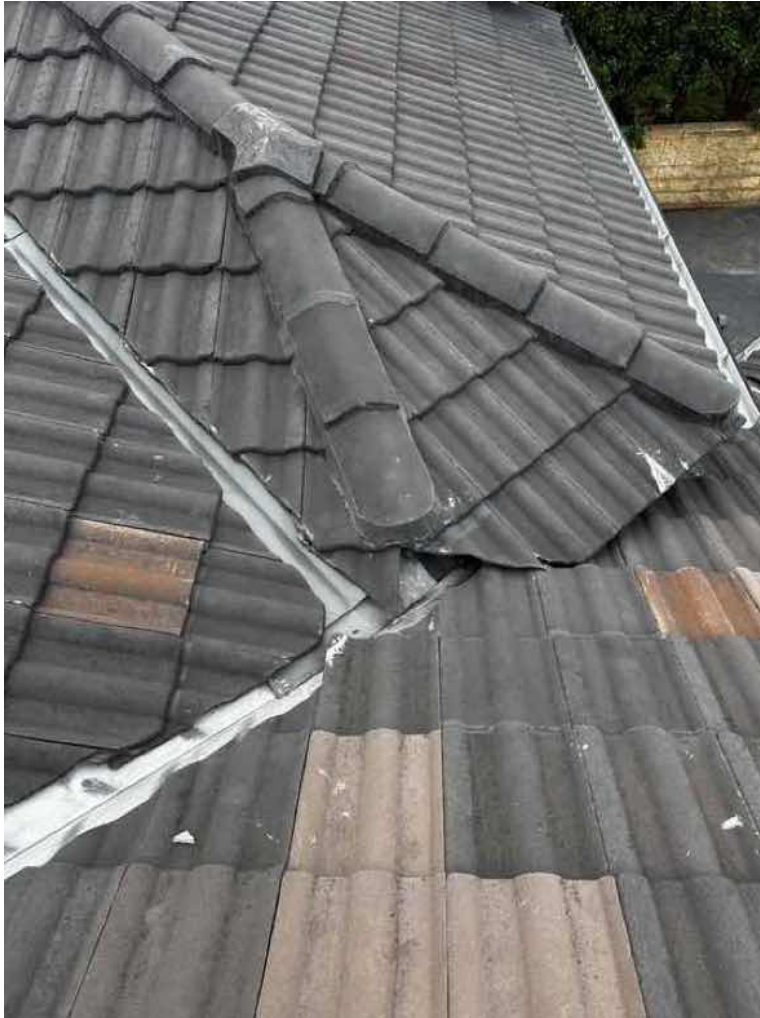
We note valley flashing to the rear intersecting roofs is considered to be of poor design and highly susceptible to blockages and backflow of water into the adjacent roof cavity areas. We recommend consideration to engaging a roofer or carpenter to alter the valley sections to reduce the likelihood of blockages and increasing the size and capability of water flow for periods of heavy/prolonged rain. Without improvements future blockages and water leaks may occur.

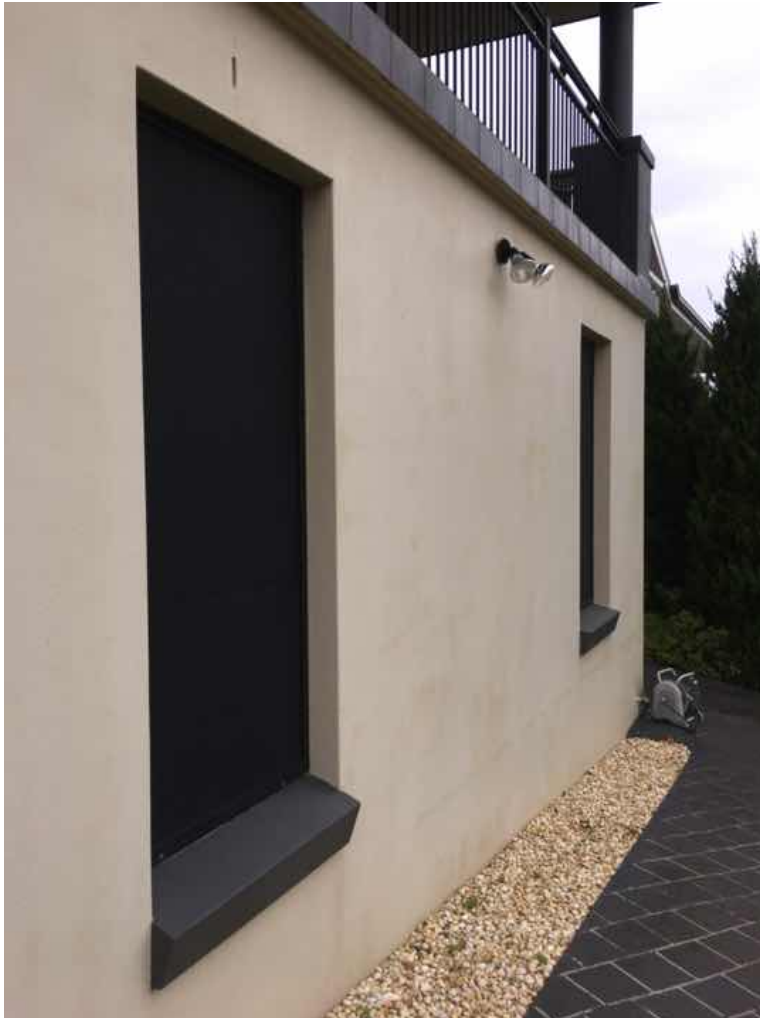
The external paint has deteriorated . External wall paint preserves and protects the building elements. Contact a licensed painter for repairs.

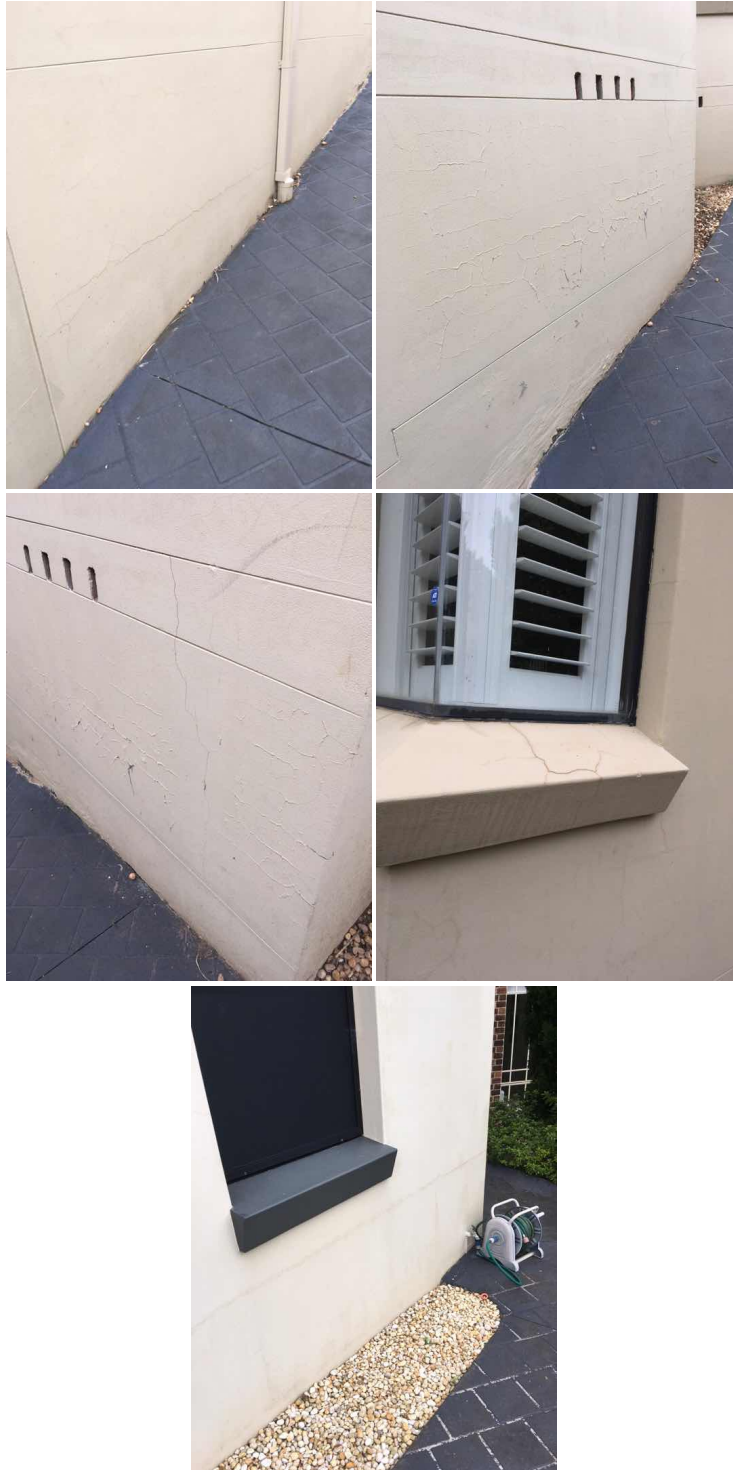
We note cracking/crazing and general surface wear and tear to render & paint finish. Cracking/crazing is likely associated with general settlement and shrinkage of render and appears to be within an acceptable tolerance at the time of inspection. Undertake general repairs to include patch/repairs surfaces and repaint/paint touch ups as required. Monitor any further cracking/crazing and investigate further and/or seek further advice if required. We note horizontal crack to render extending around most areas of the dwelling at the weep hole or air vent level is due to the omission of control joints at the Damp Proof Course level. Is it normal for minor expansion and contraction to occur at this level and is recommended a control joint be provided for rendered finishes. This is not considered a structural defect and can be easily rectified by cutting in a control joint as required.

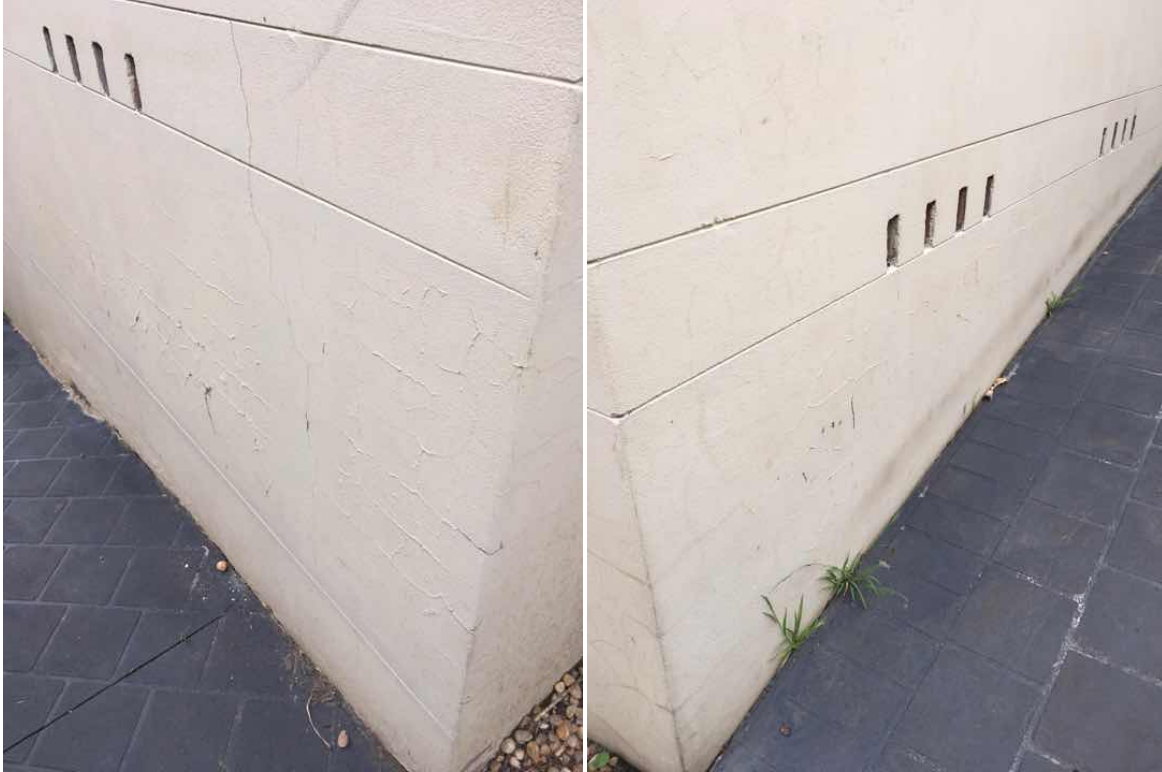
Slat build up, blistering paint and/or mortar and render deterioration to lower sections of brickwork noted. This is likely associated with excessive dampness of the adjacent soils and/or landscaping built up over brickwork DPC barriers. Improving soil drainage to the adjacent areas and lowering landscaping levels adjacent to brickwork can help reduce high moisture levels. Undertake cosmetic improvements as required.

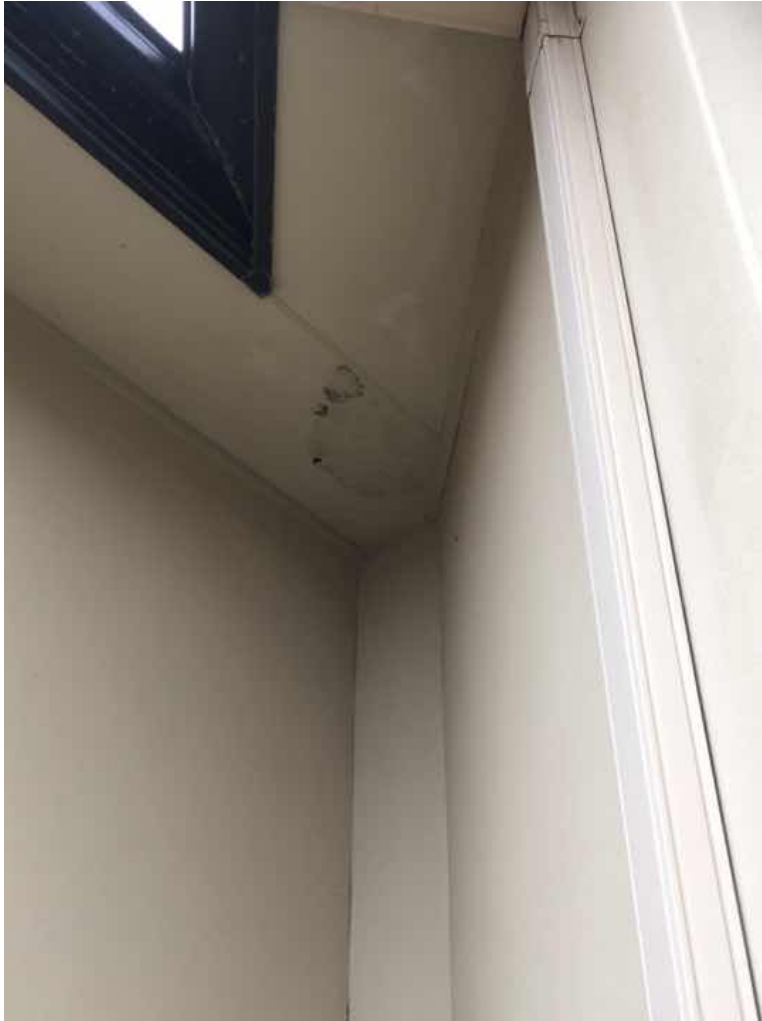
Eave lining stains observed. Normally this occurs due to overflow in blocked gutters. Recommendations. Gutters should be kept clear of debris and eave linings can then be painted or repaired as required.

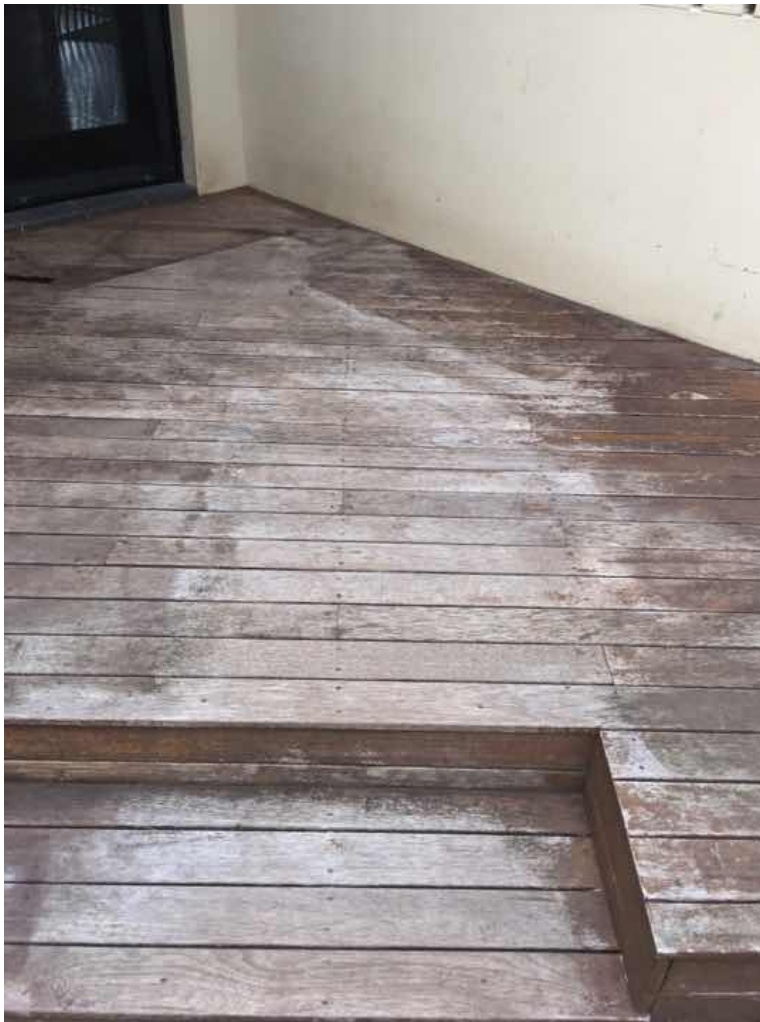
Decking board surfaces are weathered - Recommendations: We recommend cleaning and maintenance as needed.

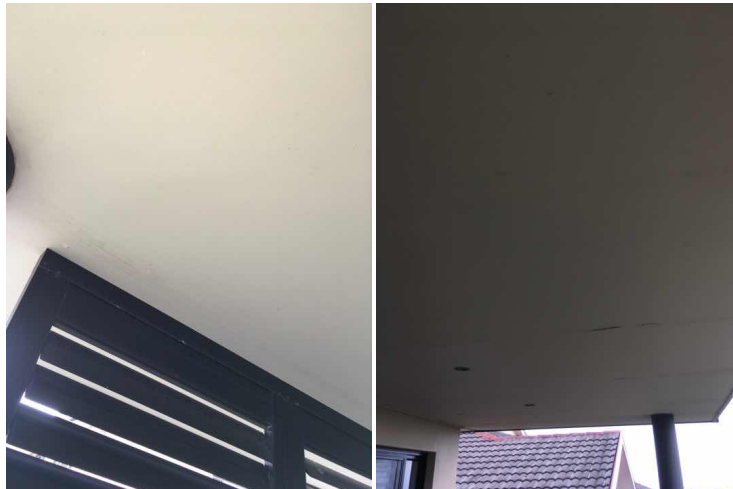
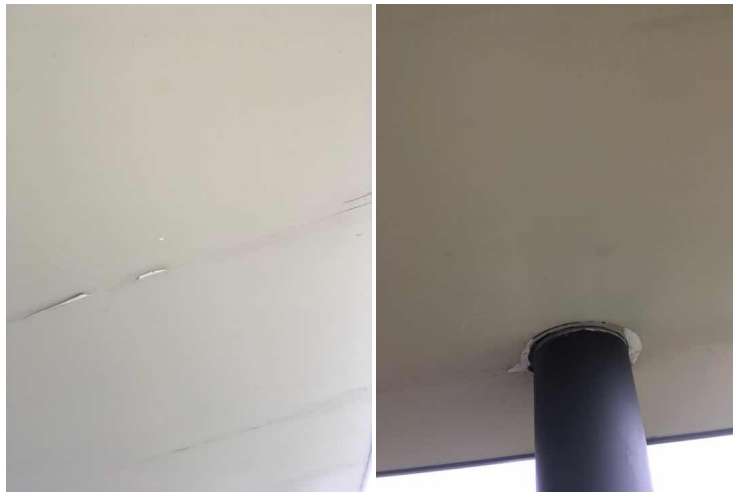
Eave lining stains observed. Normally this occurs due to overflow in blocked gutters. Recommendations. Gutters should be kept clear of debris and eave linings can then be painted or repaired as required.

Missing trim to column. Replace trim as required

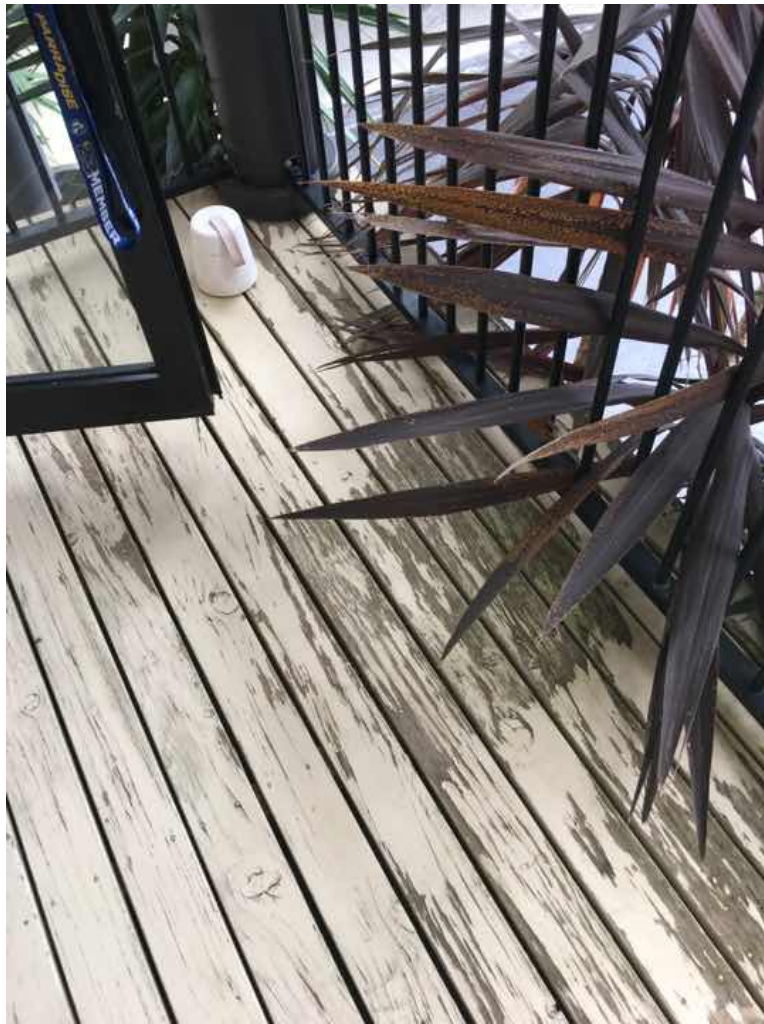
Decking board surfaces are weathered - Recommendations: We recommend cleaning and maintenance as needed.

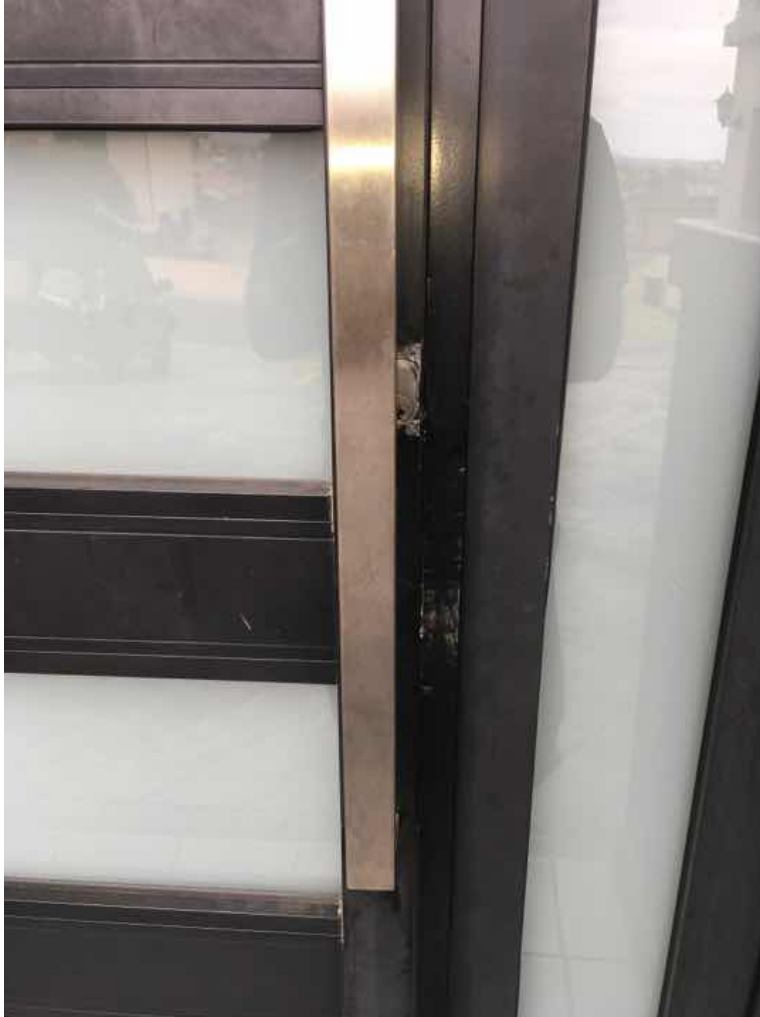
The entry door lock was obscured by handle and unable to unlock- Recommendations: A locksmith should be engaged for repairs and improve .

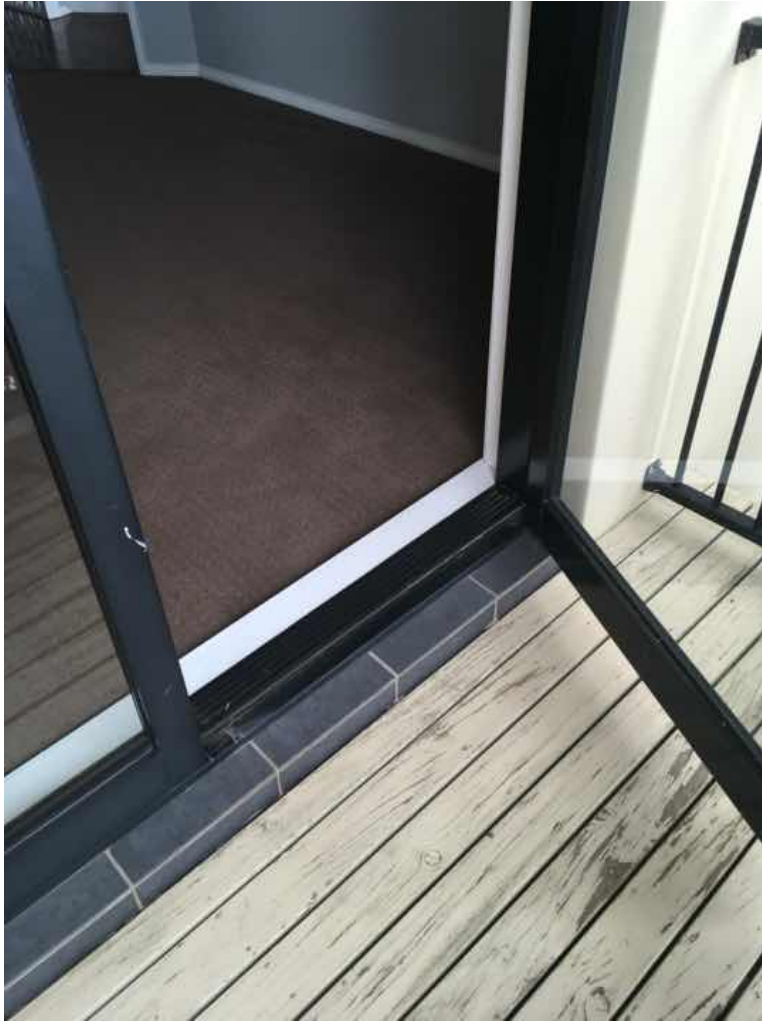
Undertake general maintenance to rear external access doors to include ease and adjust etc as required.

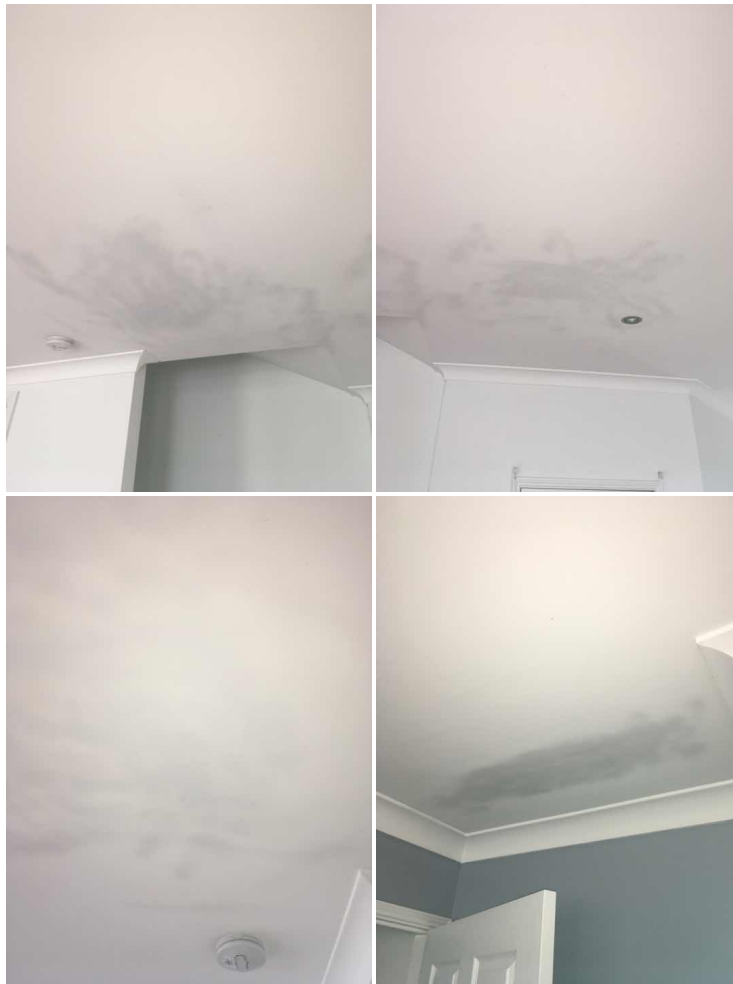
Ceiling stains - No moisture readings obtained. Recommendations: These may have been repaired, however, you will need to monitor after a prolonged period of rainfall - If leaking persists, a qualified roofing contractor should be engaged for advice and recommendations. All water damaged plaster can be cosmetically repaired

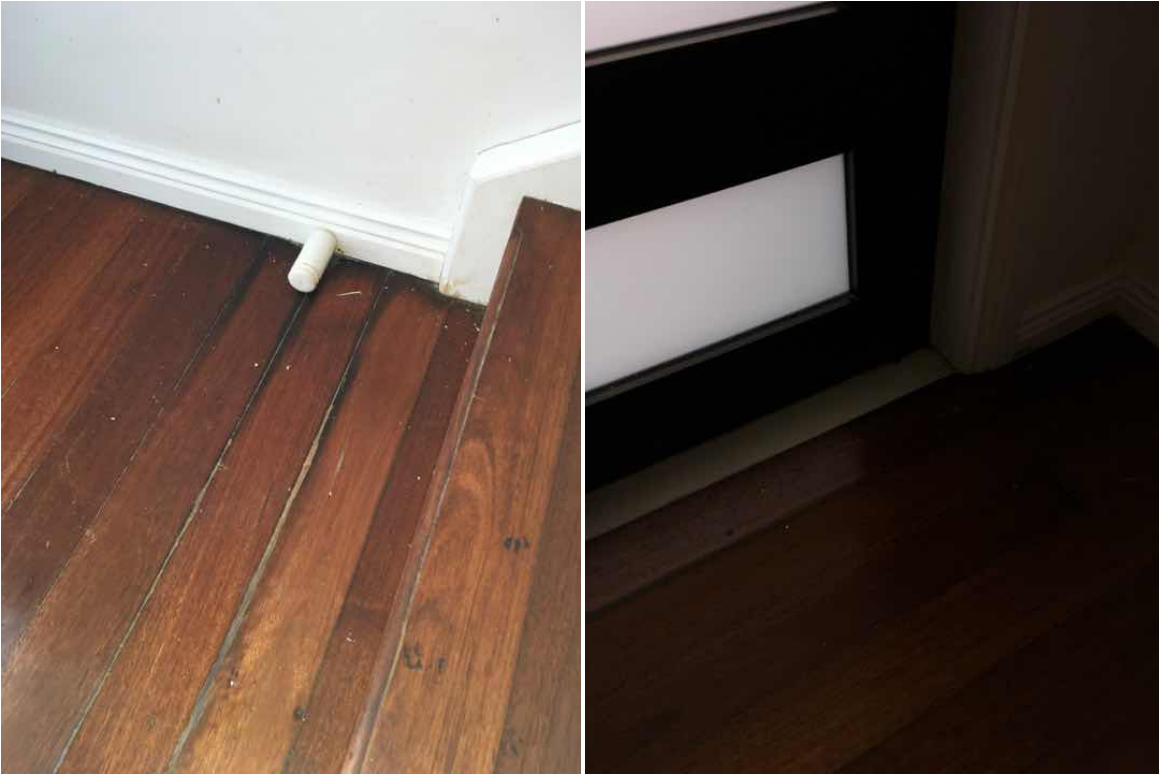
Evidence of rising dampness and elevated moisture levels to the lower timber floor boards adjacent to entry, at this is likely associated with inadequate clearance between the subfloor ground and flooring and no provision of moisture membrane during construction. Replacement of affected floorboards to include provision of adequate damp proof course in will likely be required. See subfloor section for further details regarding rising damp to subfloor

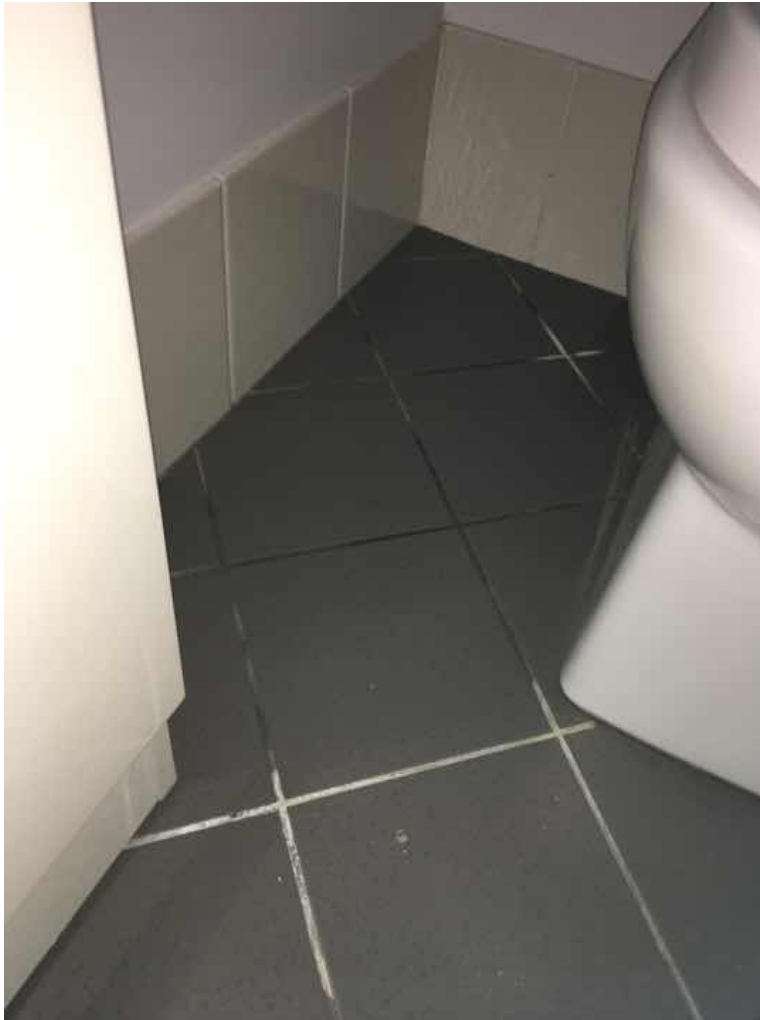
There is evidence of a water leak from a concealed water service. Contact a licensed plumber for further investigation and repairs.

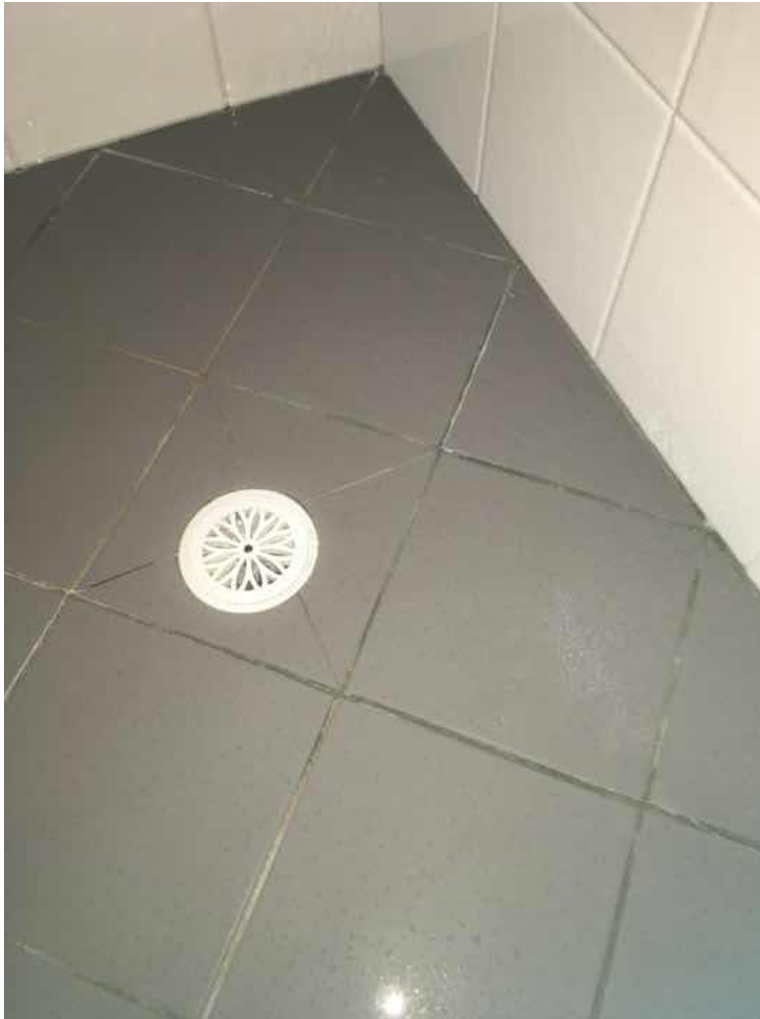
Tile grout deterioration associated with age and regular usage and is considered a common occurrence. Re-grouting and sealing the shower tiles and screen junctions is recommended. Note: without repairs water ingress behind tiles could cause tiles to become drummy, crack and result in future water leaks.

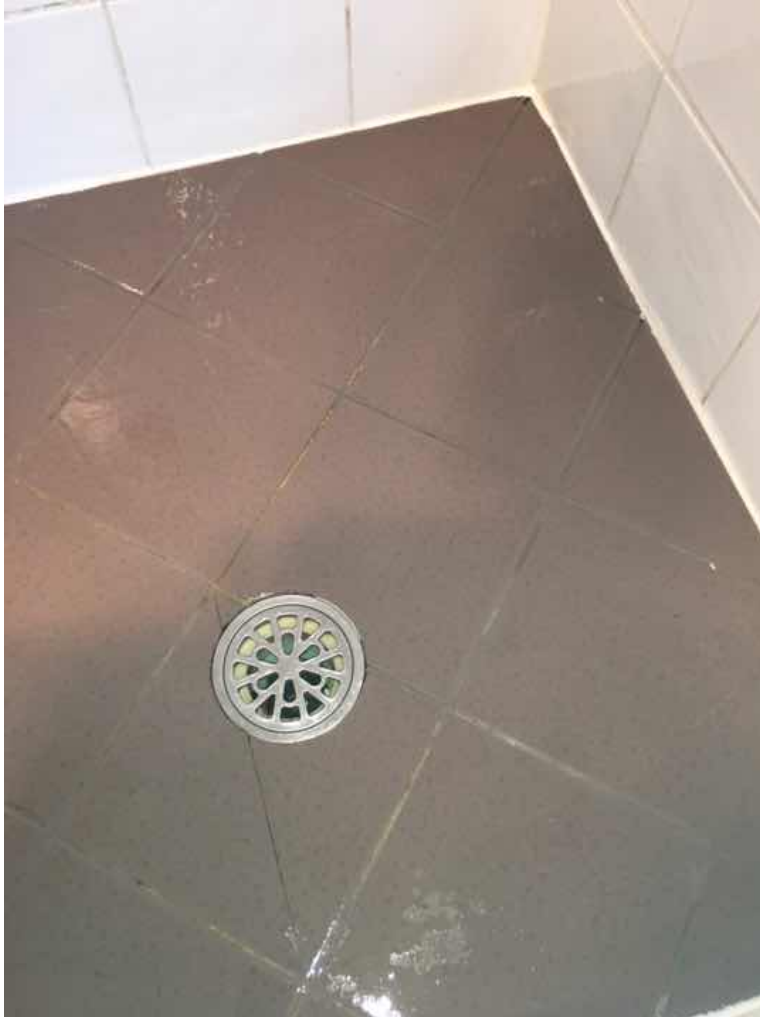
Tile grout deterioration associated with age and regular usage and is considered a common occurrence. Re-grouting and sealing the shower tiles and screen junctions is recommended. Note: without repairs water ingress behind tiles could cause tiles to become drummy, crack and result in future water leaks.

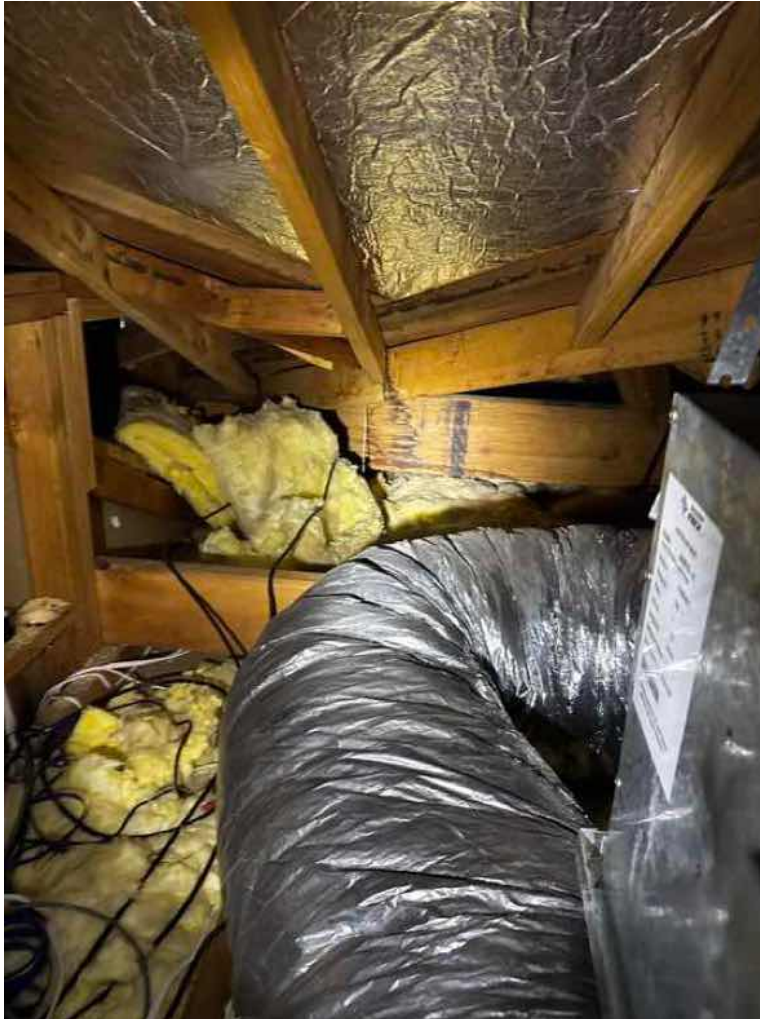
We note from a roof cavity inspection evidence of previous water leaks from valley flashings was observed. Regular cleaning of roof valleys is required to prevent any blockages and potential water leaks etc. undertake routine maintenance to valleys and reassess for any further water leaks during periods of rain and investigate further if required.

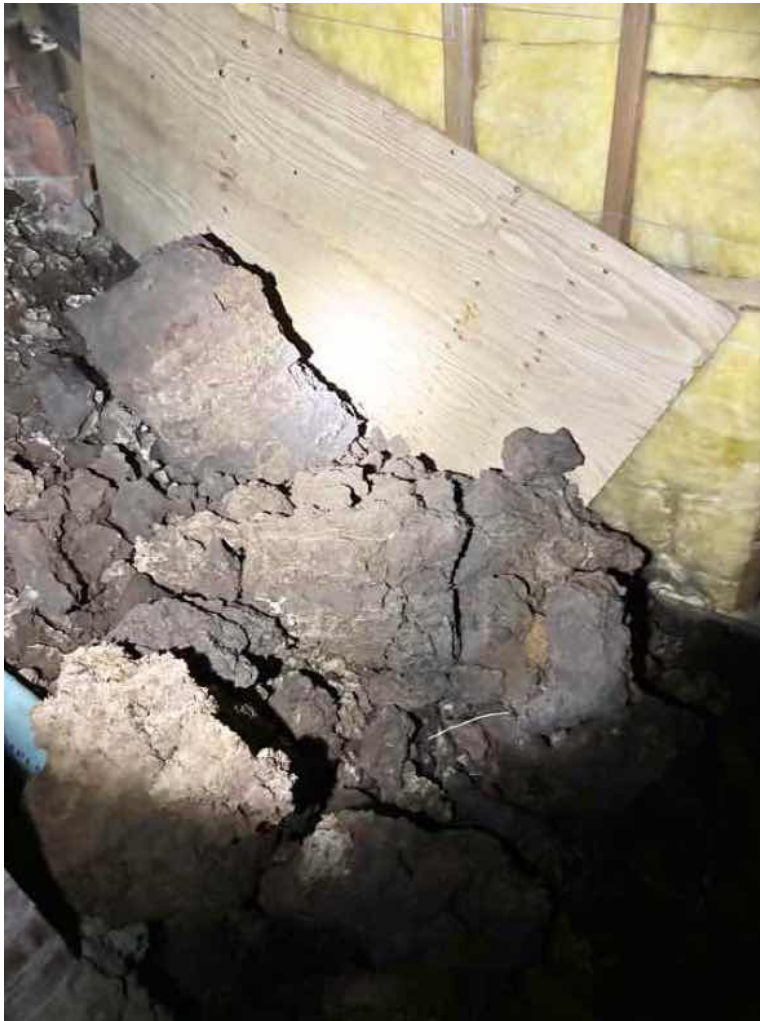
Timber wall frame timbers to lower areas are in direct contact with soil. Timbers in direct contact with soil are susceptible to timber decay, moisture ingress and termite attack. Improvements are required immediately. Engage licenced builder for repairs.

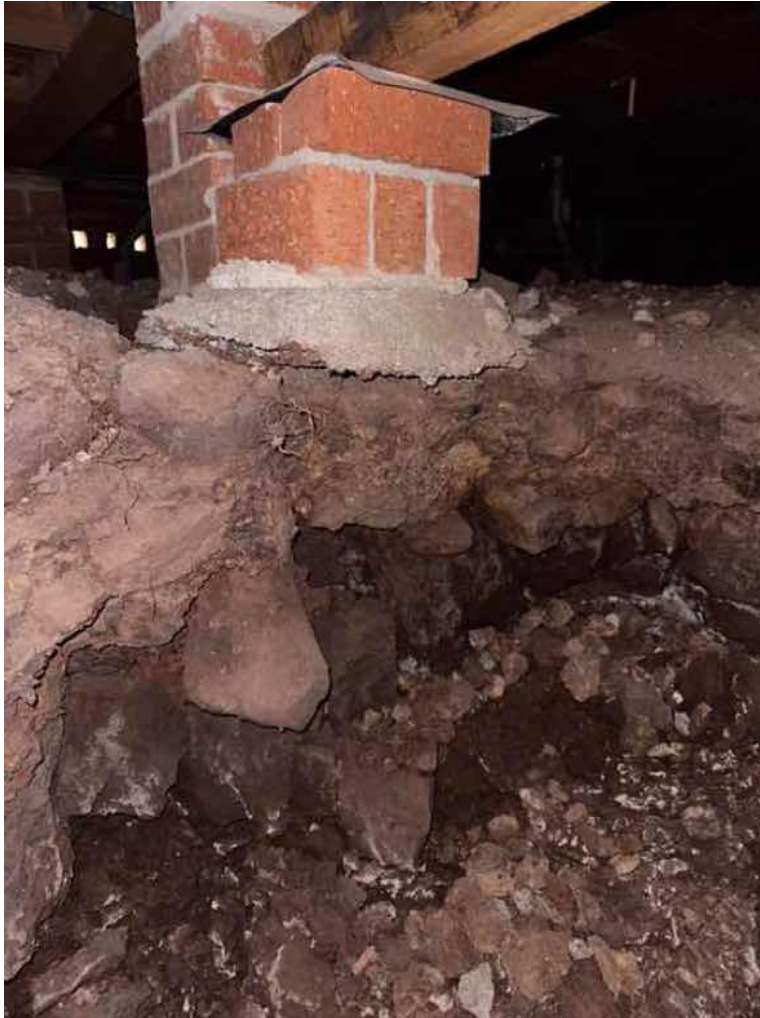
We note some sheer failure of unretained clay embankment in the subfloor area and recommend retaining same in accordance with an engineers advice/ designed to incorporate suitable drainage detail. Further investigation/ consultation with an engineer is recommended prior to purchase

We note soil erosion of the unretained clay embankment area has undermined the foundations to individual piers and may cause significant/ further movement/ rotation. Pier foundations will require repairs/ improvements to include installation of retaining walls and or new piers etc in accordance with an engineers specifications and recommendations.

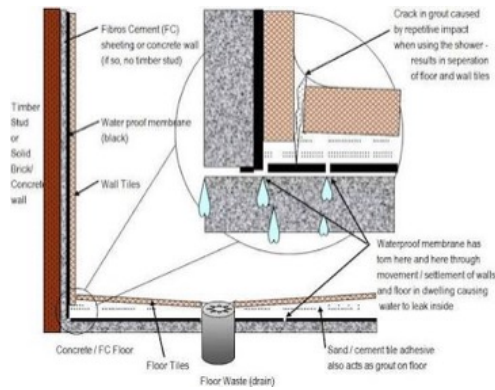
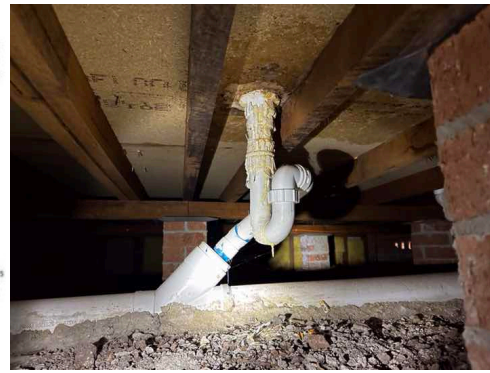
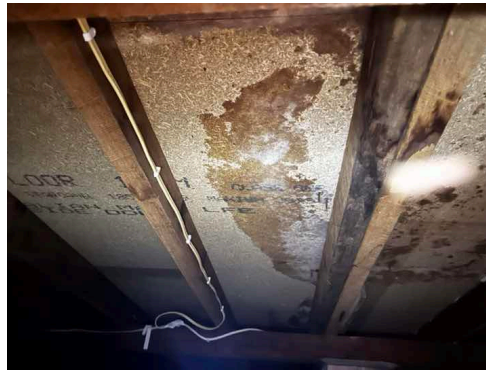
Evidence of current leaking shower recess (both showers) into the sub-floor areas was apparent at the time of inspection. Water leaks into the sub-floor area has the potential to cause significant damage and timber decay. Engage a waterproofing specialist to rectify leaking shower recess ***immediately***

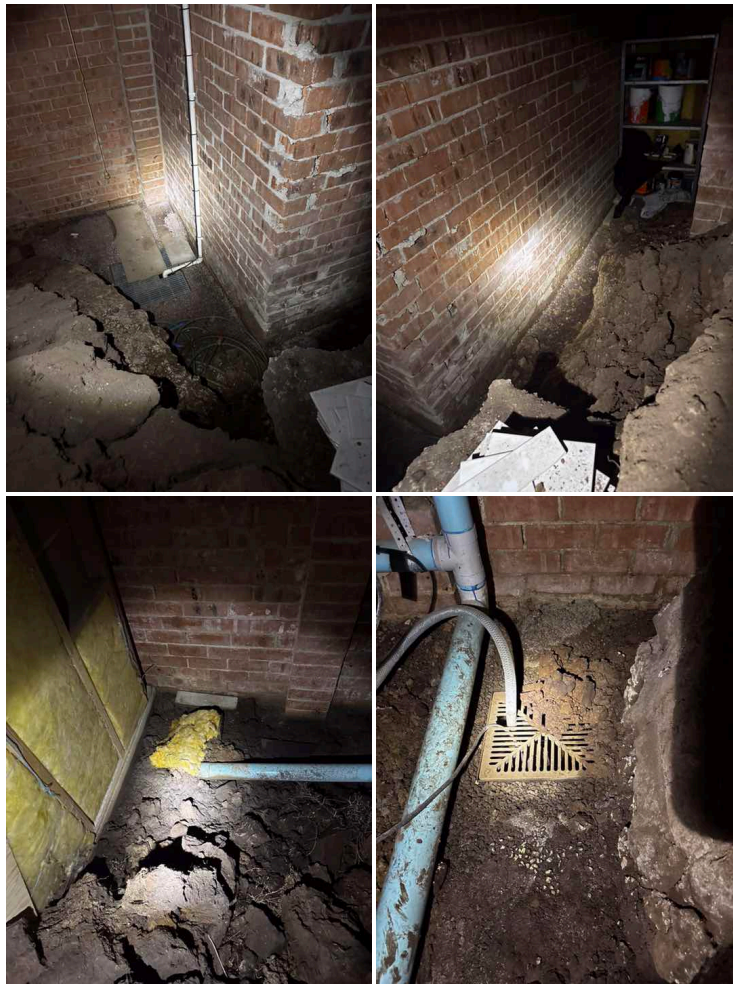
Elevated moisture levels were detected to the lower entry walls and floors due to the omission of suitable drainage and waterproofing membrane to the subfloor side. We recommend engaging a plumber and waterproofing contractor to remove buildup soils, apply a suitable Waterproofing membrane to the lower wall areas and Install suitable drainage within the subfloor as per there recommendations.

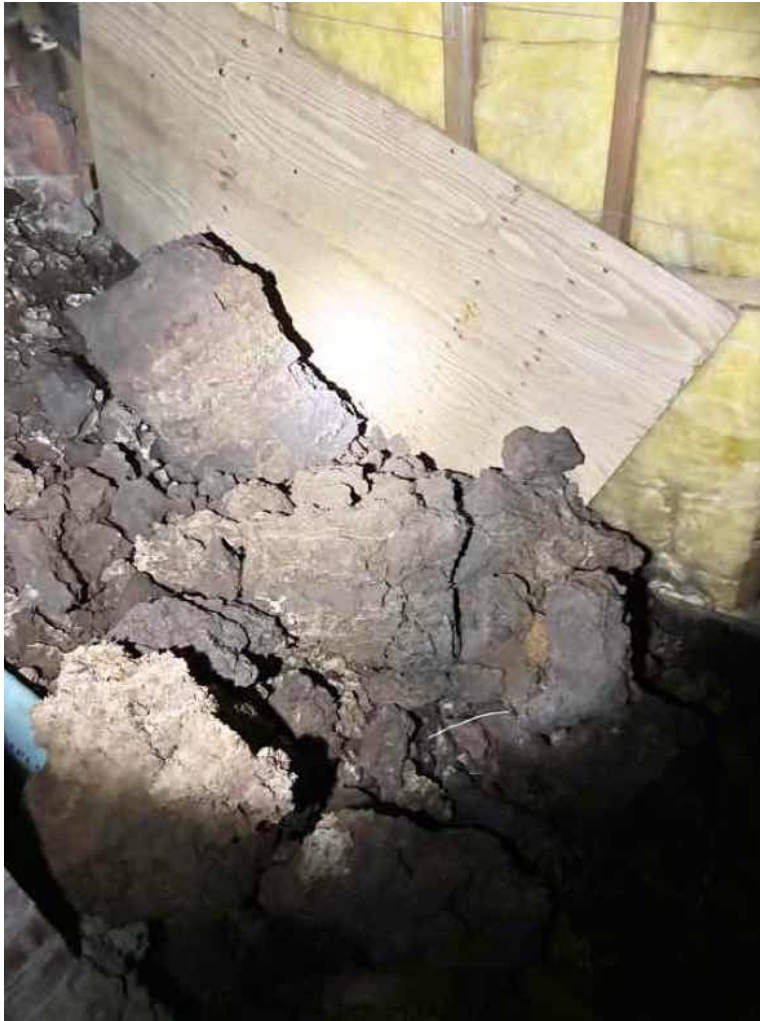
No. Slab edge could be exposed a minimum of 75mm.
