Inspection Report

Complete Building Inspection Services

6 Yarle Crescent, Flinders, NSW, 2529

Pest And Building Inspection

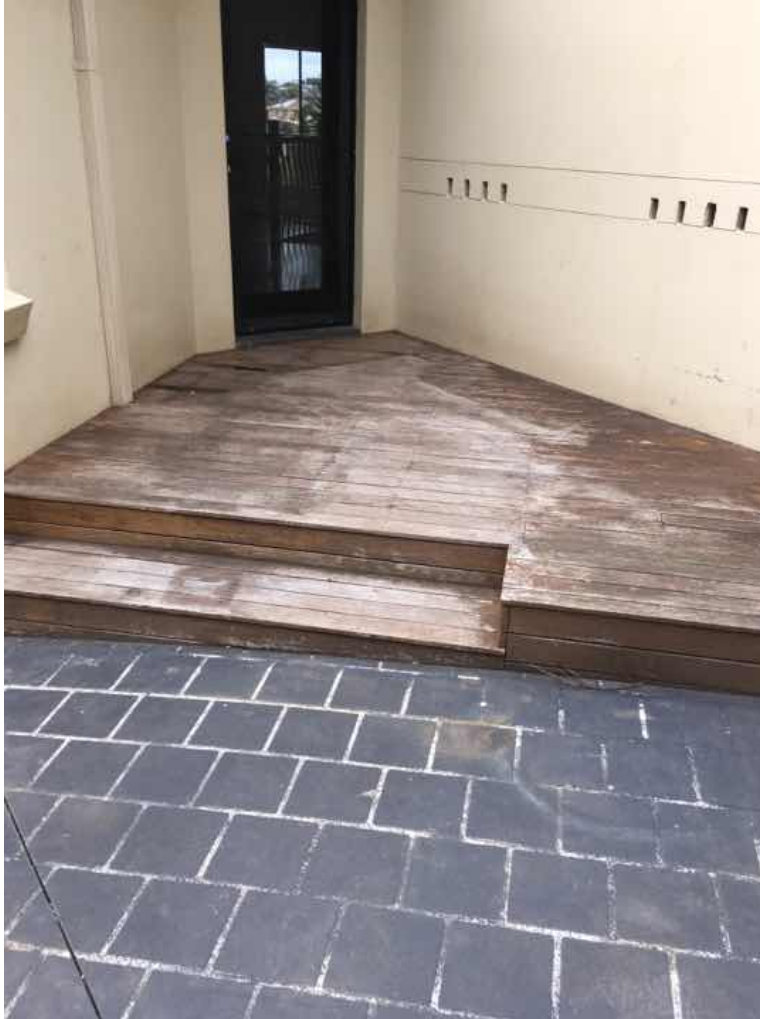
Of areas visible, minor defects and/or maintenance issues were visible. These will require assessment and subsequent repairs by a licensed tradesperson. Please read below for details. Please note that the inspector believes these to be of a minor nature relative to the age of the dwelling and or lack of proper and continual maintenance. Others, including other inspectors may differ in their opinions.

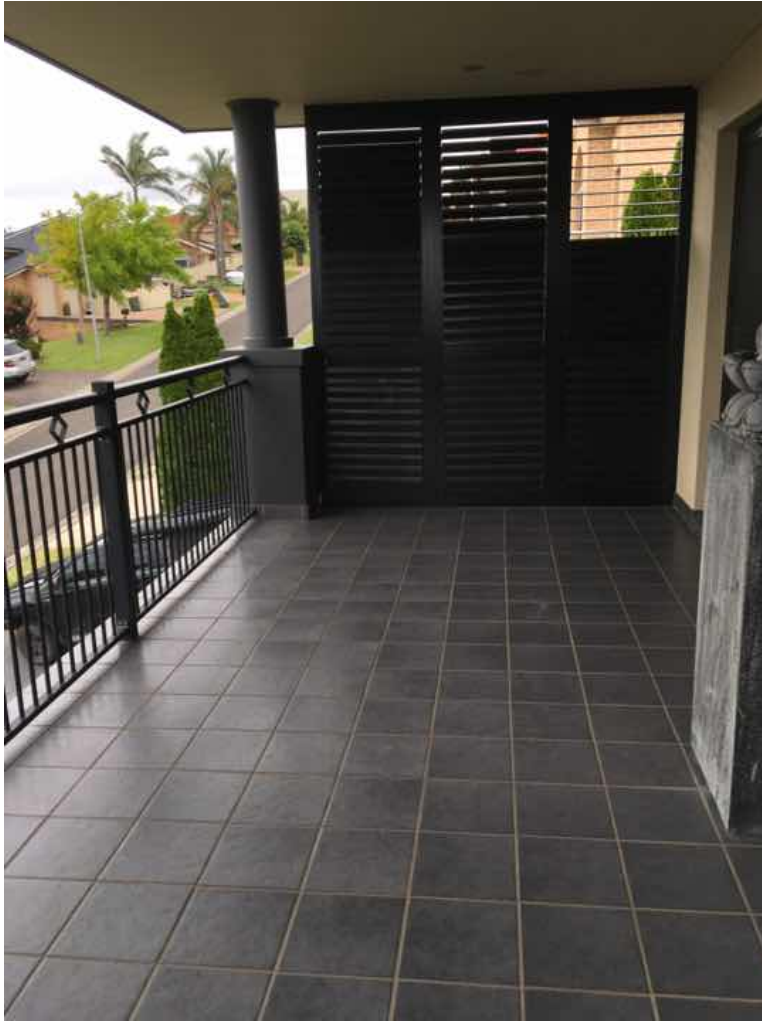
Of areas visible, minor defects and/or maintenance issues were visible. These will require assessment and subsequent repairs by a licensed tradesperson. Please read below for details. Please note that the inspector believes these to be of a minor nature relative to the age of the dwelling and or lack of proper and continual maintenance. Others, including other inspectors may differ in their opinions.

We recommend regular inspection of the structure and condition of all fixings including integrity of concealed and inaccessible fixings and any handrail/balustrades which are exposed to the elements at least every six months by a suitably qualified engineer to ensure the ongoing structural integrity and safety of the structure, handrail/balustrades and fixings. *Note: exposed steel fixings etc are susceptible to corrosion/deterioration/failure at any time. Care/common sense should be taken not to overload the structure*

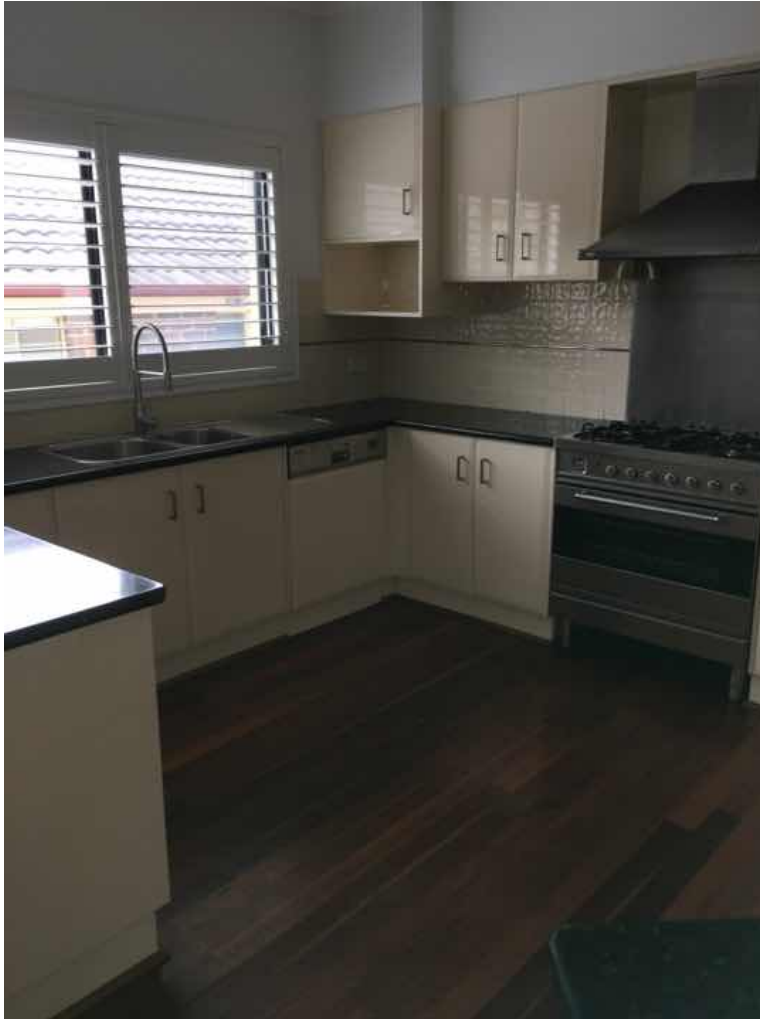
Of the visible areas, the general condition is serviceable or in reasonable condition for age of dwelling.

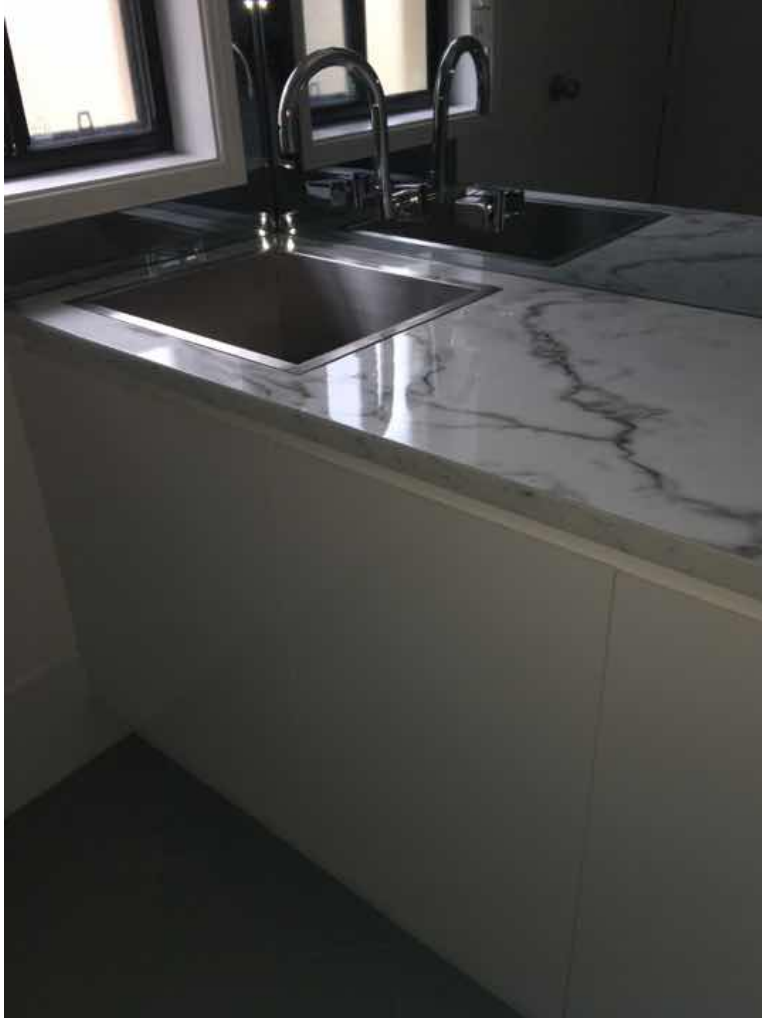
Laundry tub/sink and any associated cabinets and benchtops etc appears to be in a good serviceable condition with no notable defects detected.

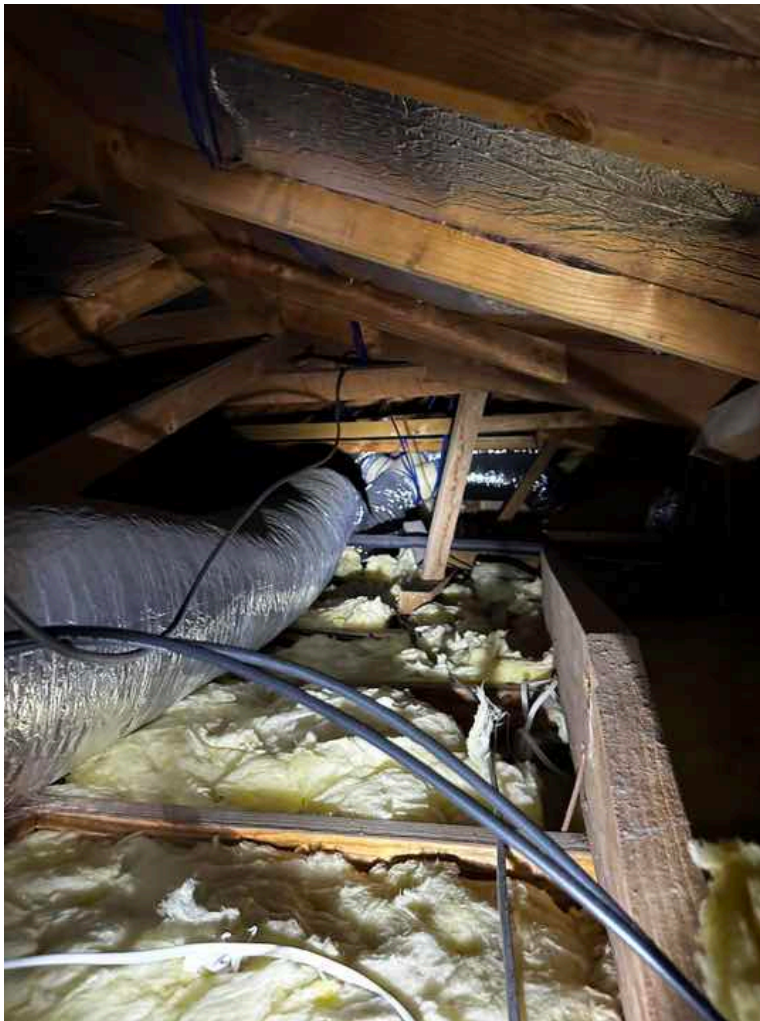
Visible sections of the roof void is in a serviceable condition for age of this dwelling.
